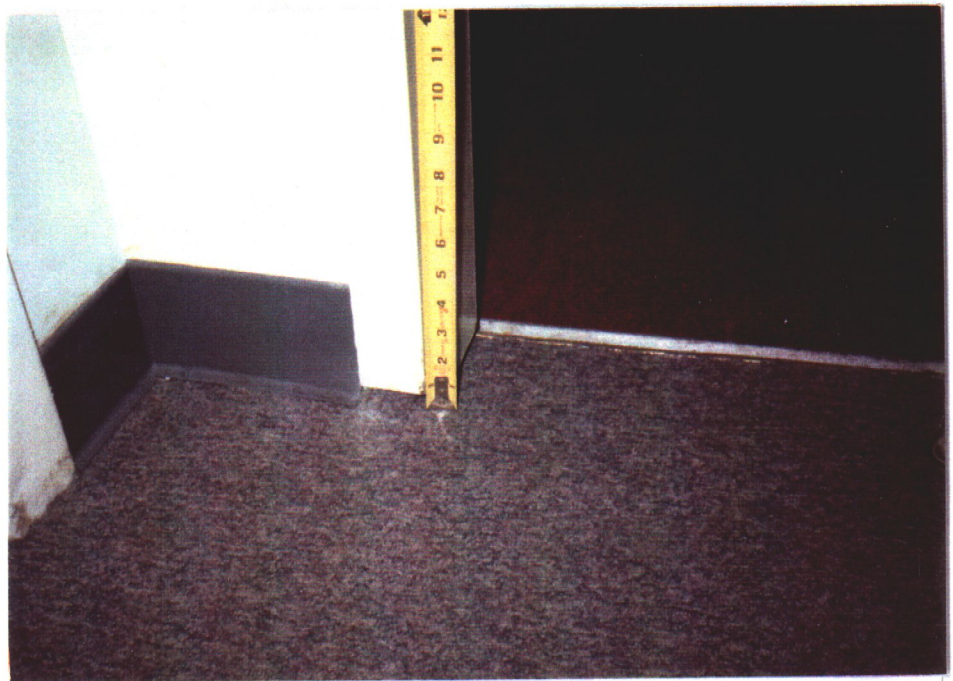
PHOTO # 1

DOORWAY AT ROOM 8114, LARGE GAP AT BOTTOM OF HOLLOW
METAL DOOR FRAME

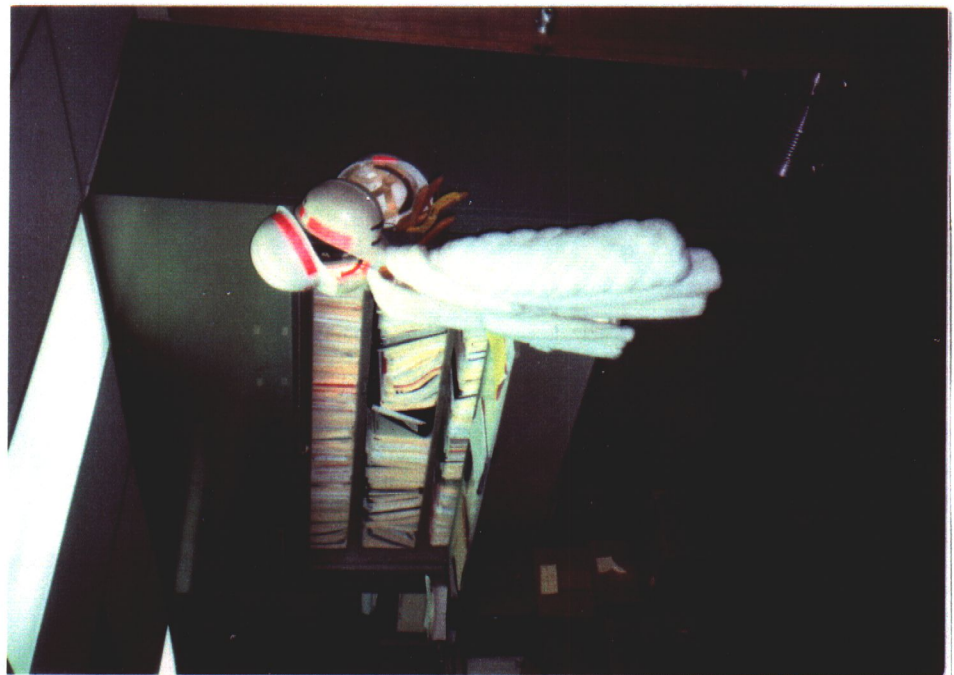
PHOTO # 2

LEKTREIVER HIGH DENSITY FILING SYSTEM
INSIDE ROOM 8114

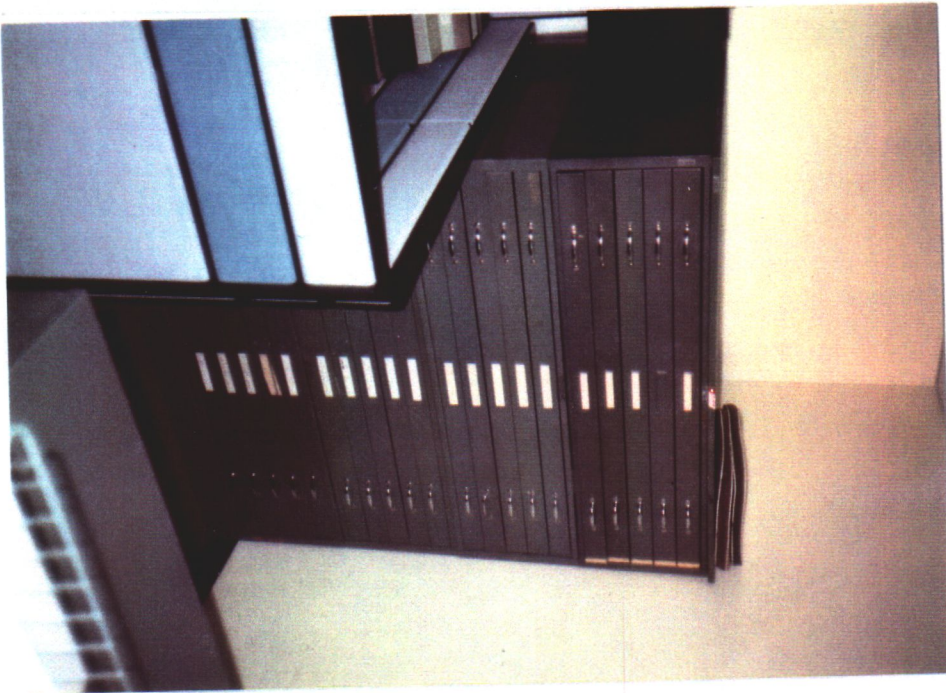
PHOTO # 3

ROOM 8403, MAP FILE IN THE COE
CONSTRUCTION OPERATIONS

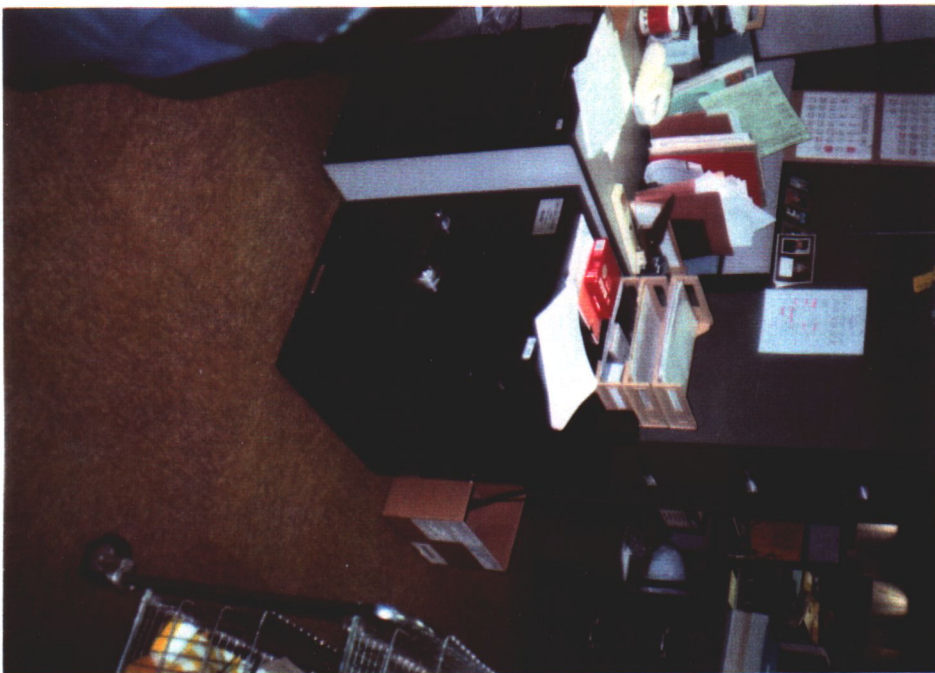
PHOTO # 4

ROOM 8006, SMALL SAFE IN ACCOUNTING
AND FINANCE OFFICE

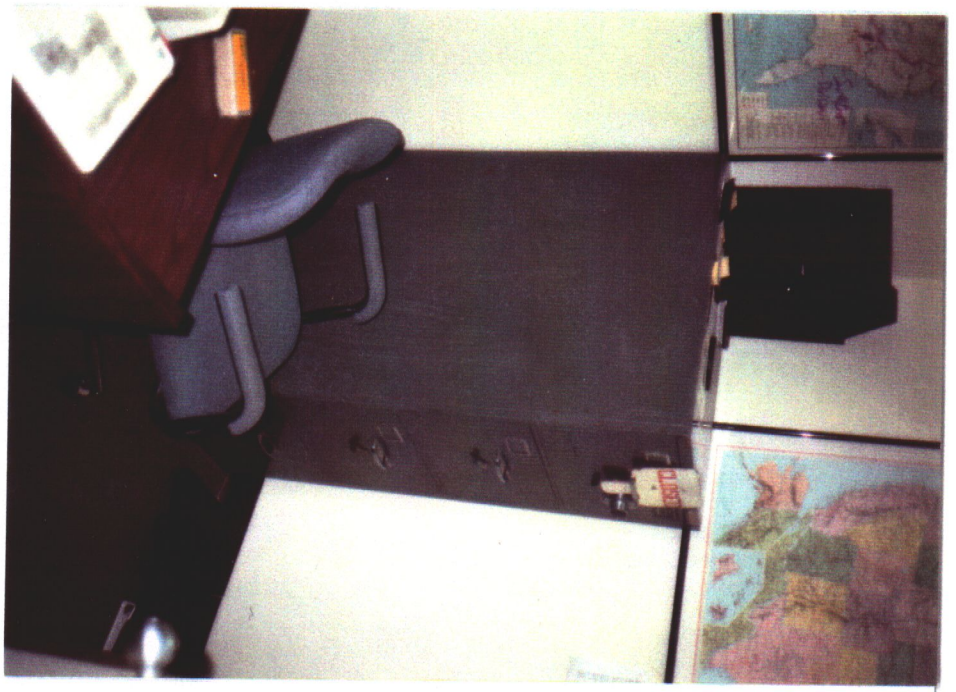
PHOTO # 5

ROOM 8433A, FIVE (5) DRAWER SAFE

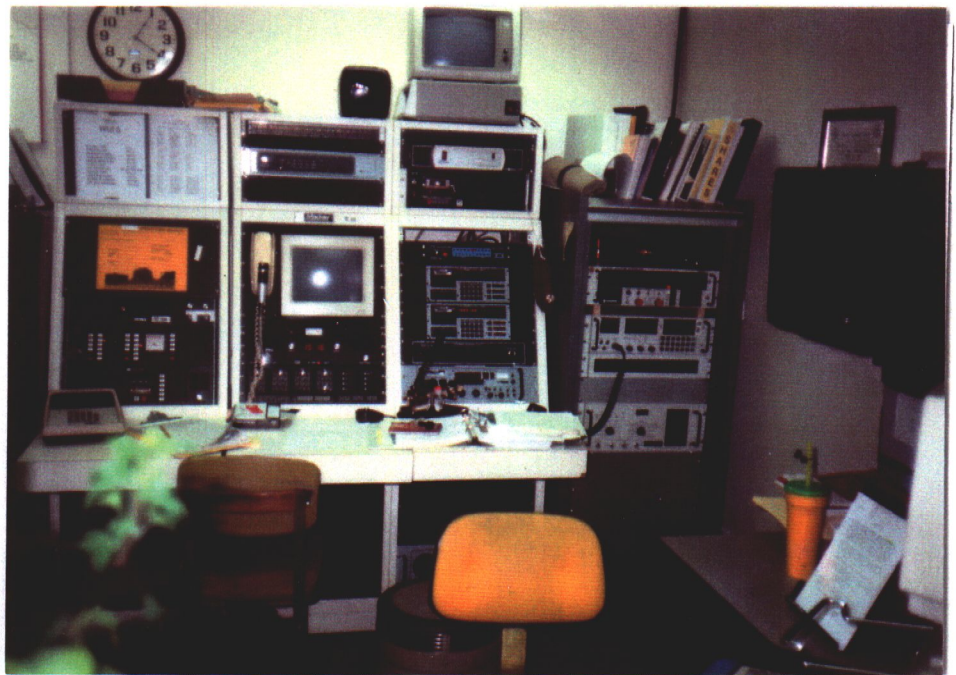
PHOTO # 6

ROOM 8437, LARGE RADIO

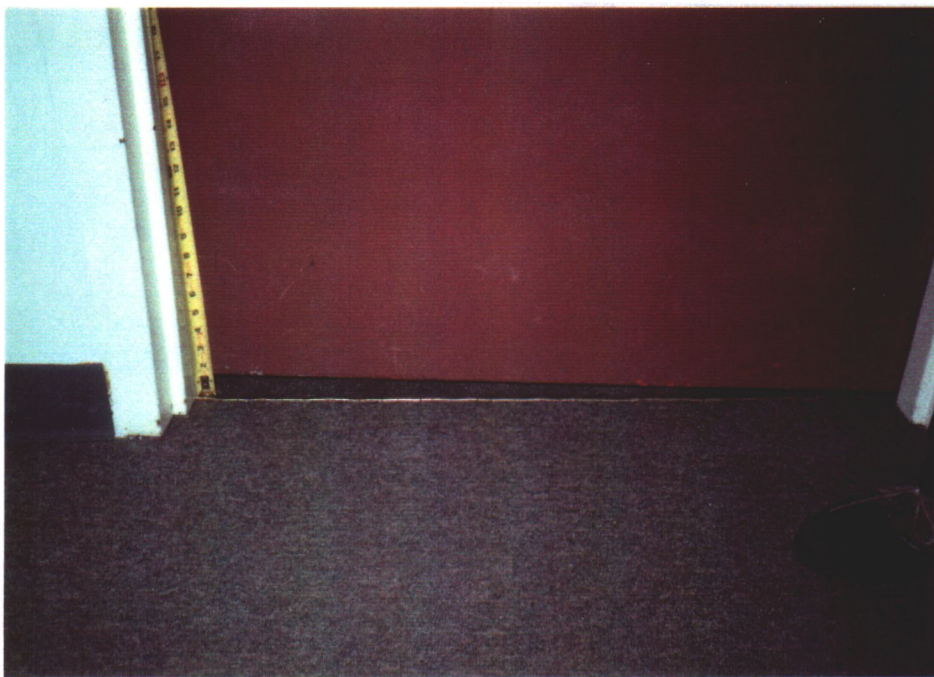
PHOTO # 7

ROOM 8313, LARGE DEFLECTION AT DOORWAY FROM CORRIDOR
INTO CONFERENCE ROOM

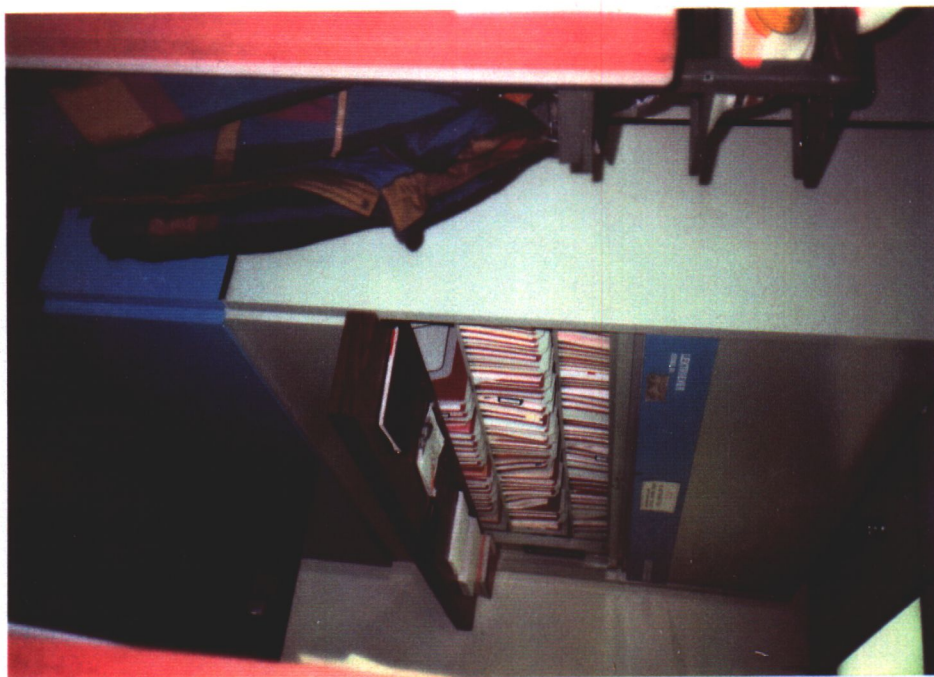
PHOTO # 8

ROOM 7021, LEKTRIEVER INSIDE COE SPACE
